Facility: Thomas Hayward Agriculture & Nutrition

Subject: Area in front of the facility (on the south side of the property) looking west with the Harcros facility in the background.

RCRA 6/27/1995

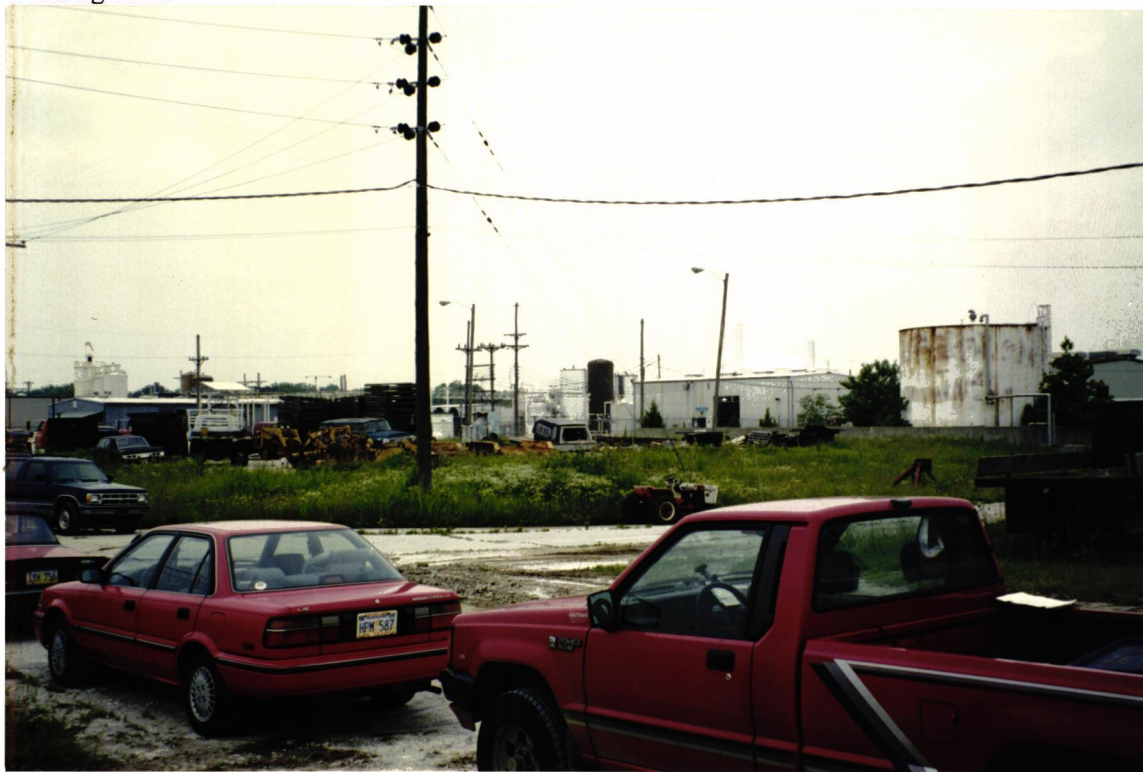
Subject: View of the property looking west-northwest. The large tank at the right side of the photo is the former #5 diesel fuel tank.

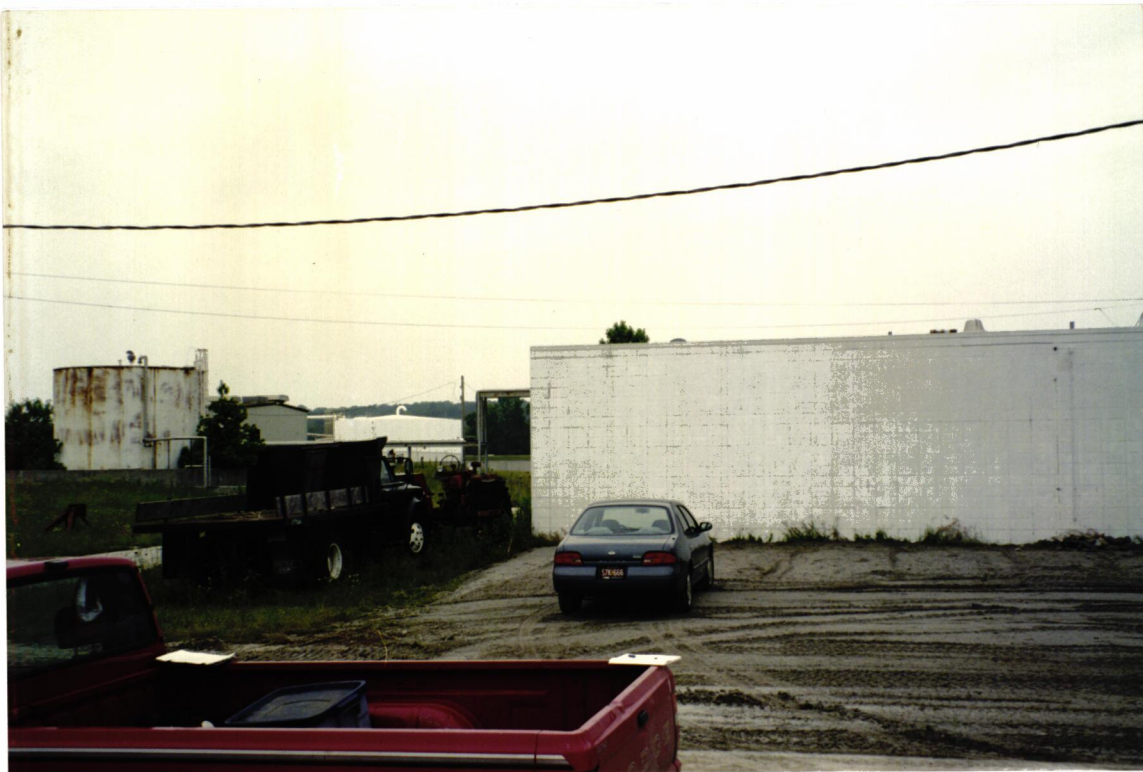
3

Facility: Thomas Hayward Agriculture & Nutrition
Location: Kansas City, KS **Photographer:** Jeffery Robichaud **Witness:** None **Date:** 6/27/95
Direction: North-northwest **Camera Type:** Fuji 35mm **Film Type:** 200 ASA **Time:** 0840
Subject: View of the property showing the #5 diesel fuel tank at the left and the former laboratory/office building at the right (white cinder block building).

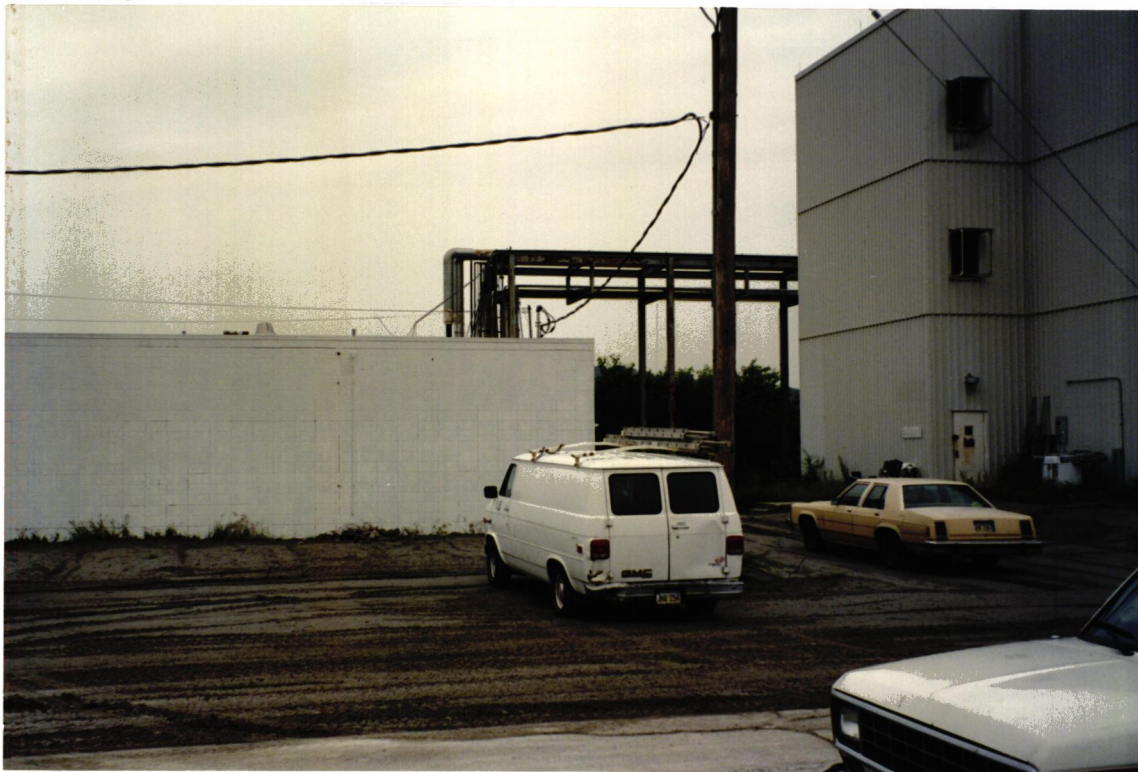
4

Facility: Thomas Hayward Agriculture & Nutrition
Location: Kansas City, KS **Photographer:** Jeffery Robichaud **Witness:** None **Date:** 6/27/95
Direction: North **Camera Type:** Fuji 35mm **Film Type:** 200 ASA **Time:** 0840
Subject: View of the property facing north with a portion of the former laboratory/office building at the left and a portion of the former DAITOM building at the right.

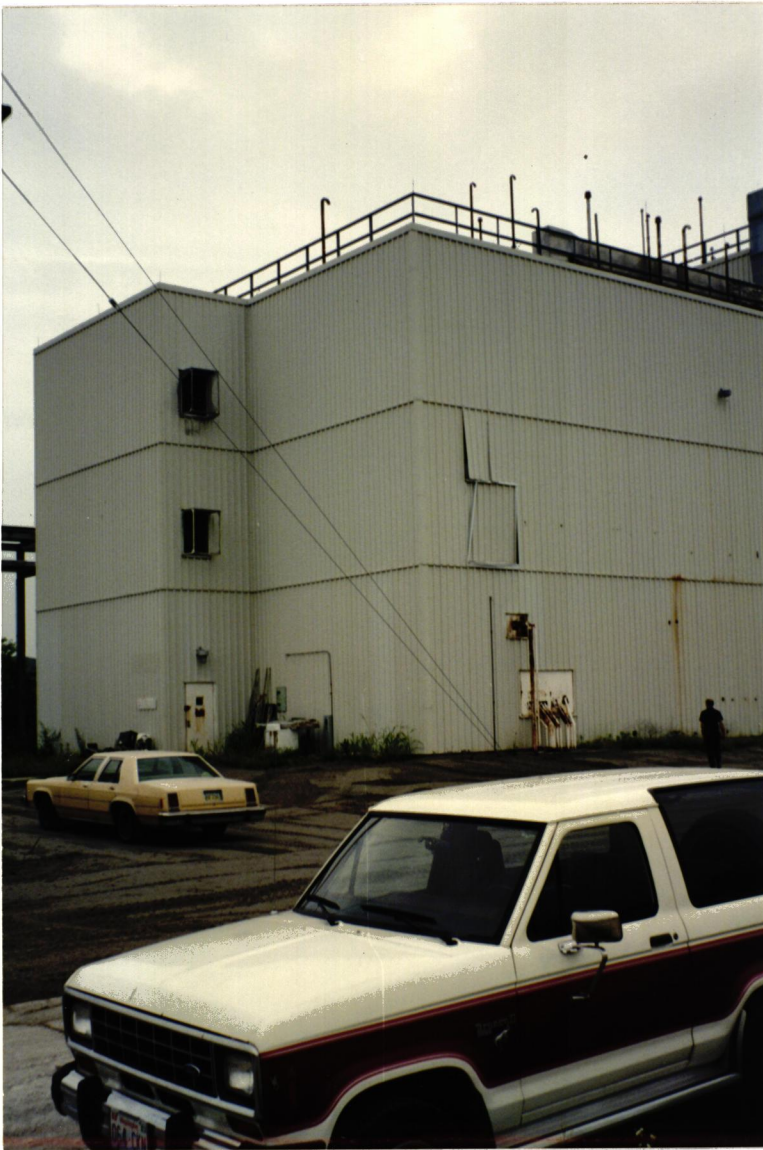
ROLL 1 PHOTO 5

Subject: View of the former DAITOM building.

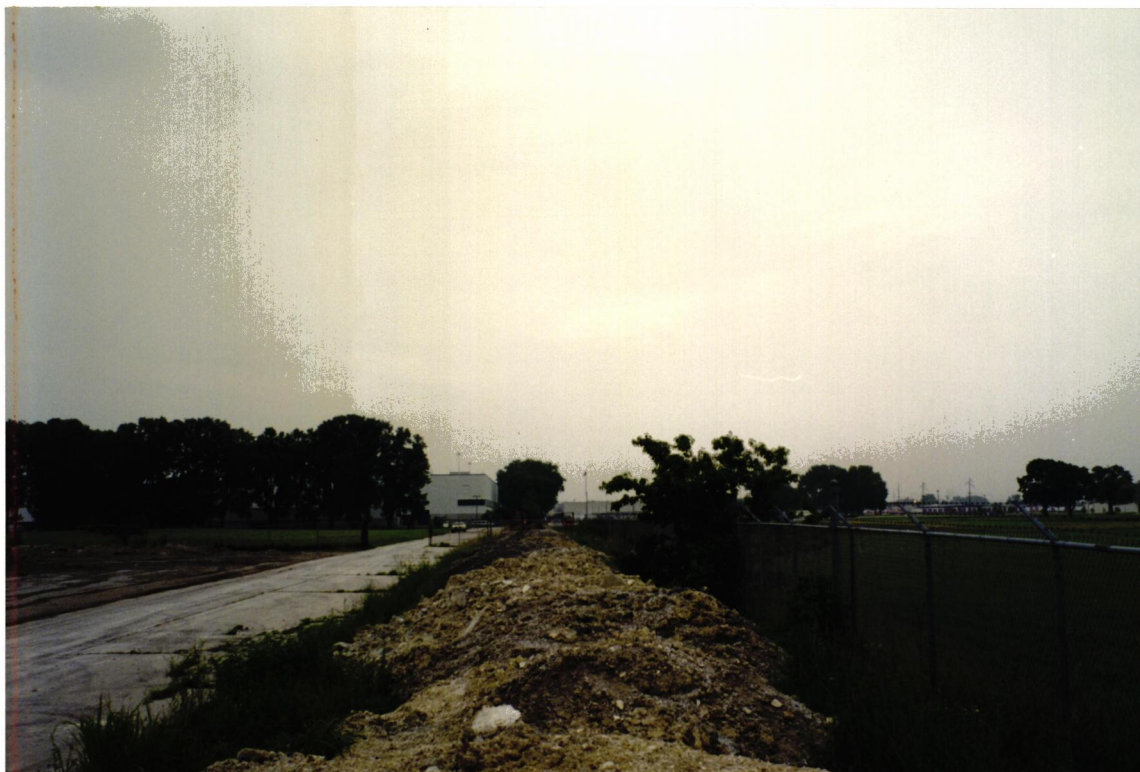
7

Subject: View of the property facing east with the Postal Bulk Mail Center in the background. Note the piles of material stacked along the fence.

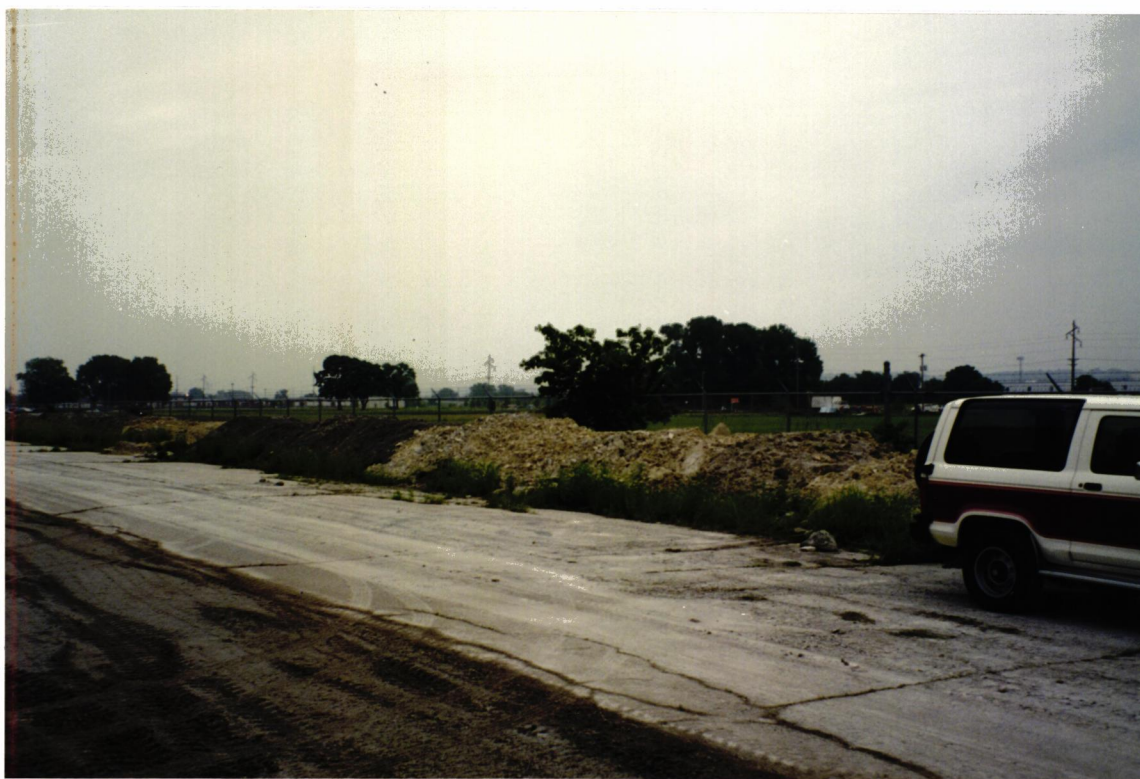
Subject: Material located along the south fence in front of the former DAITOM plant.

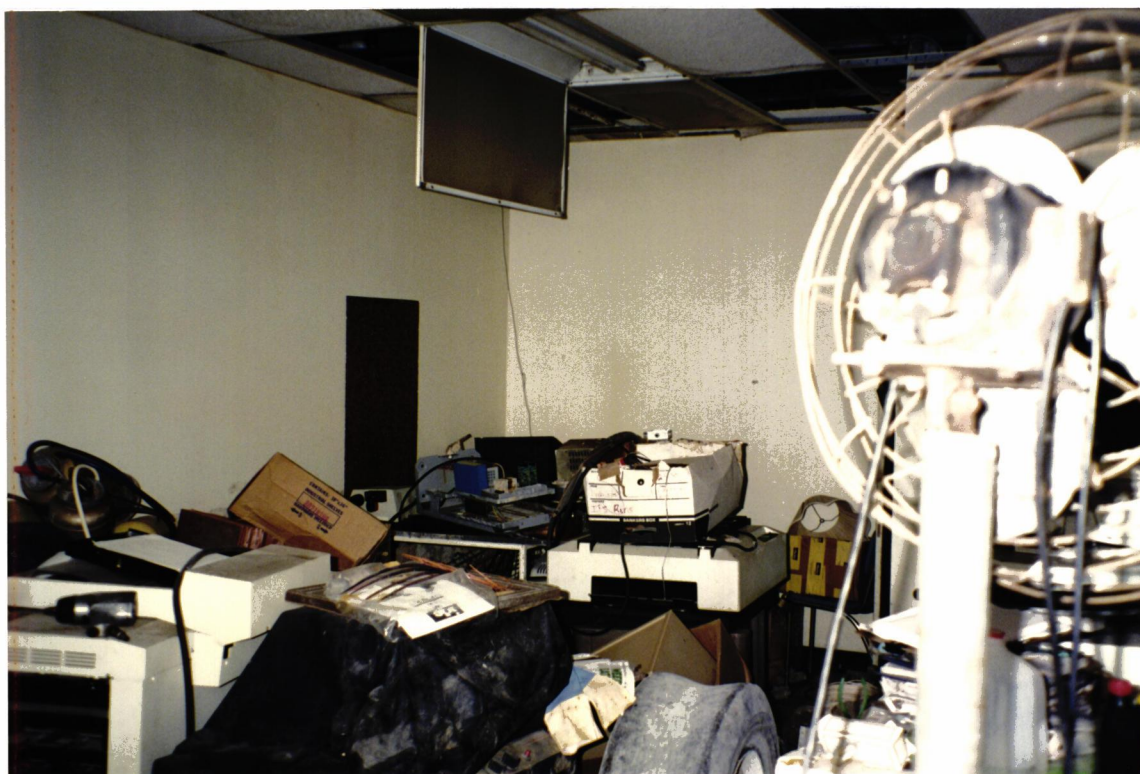
9

Subject: View of the southeast corner of the former lab room. Note the miscellaneous equipment and scrap/salvaged material.

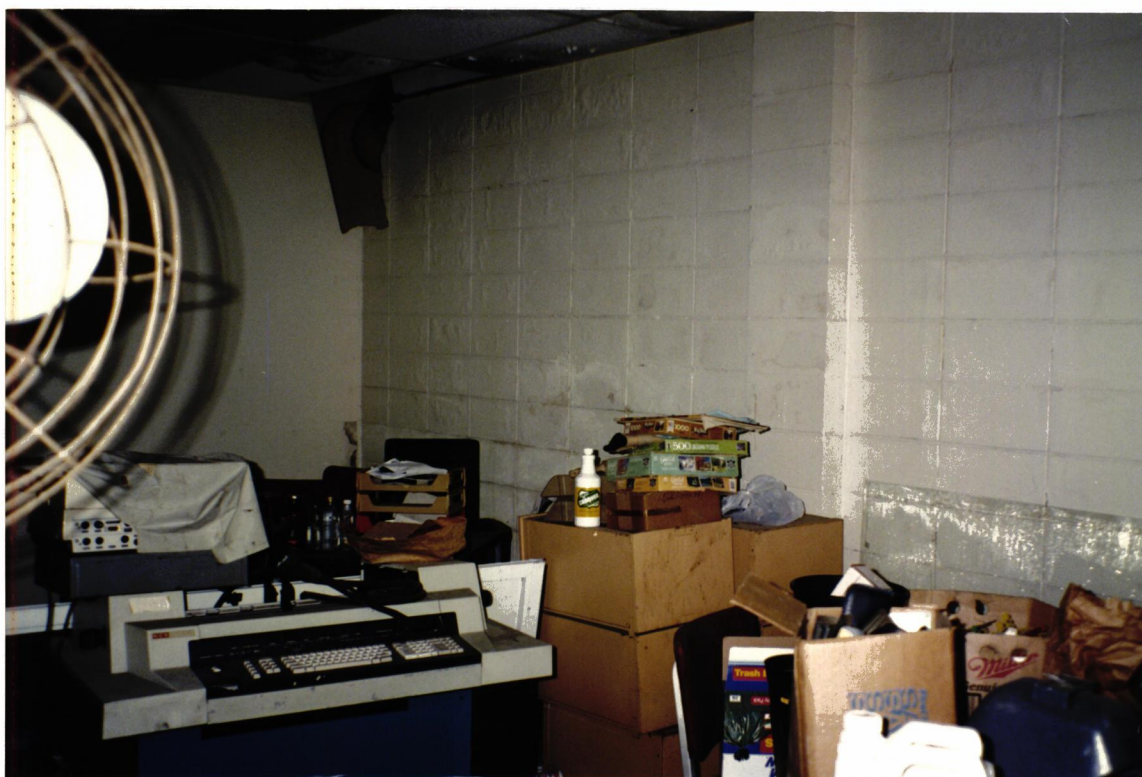
Facility: Thomas Hayward Agriculture & Nutrition
Location: Kansas City, KS **Photographer:** Jeffery Robichaud **Witness:** None **Date:** 6/27/95
Direction: Southwest **Camera Type:** Fuji 35mm **Film Type:** 200 ASA **Time:** 0845
Subject: View of the southwest corner of the former lab room. Note the bottles in the southwest corner.

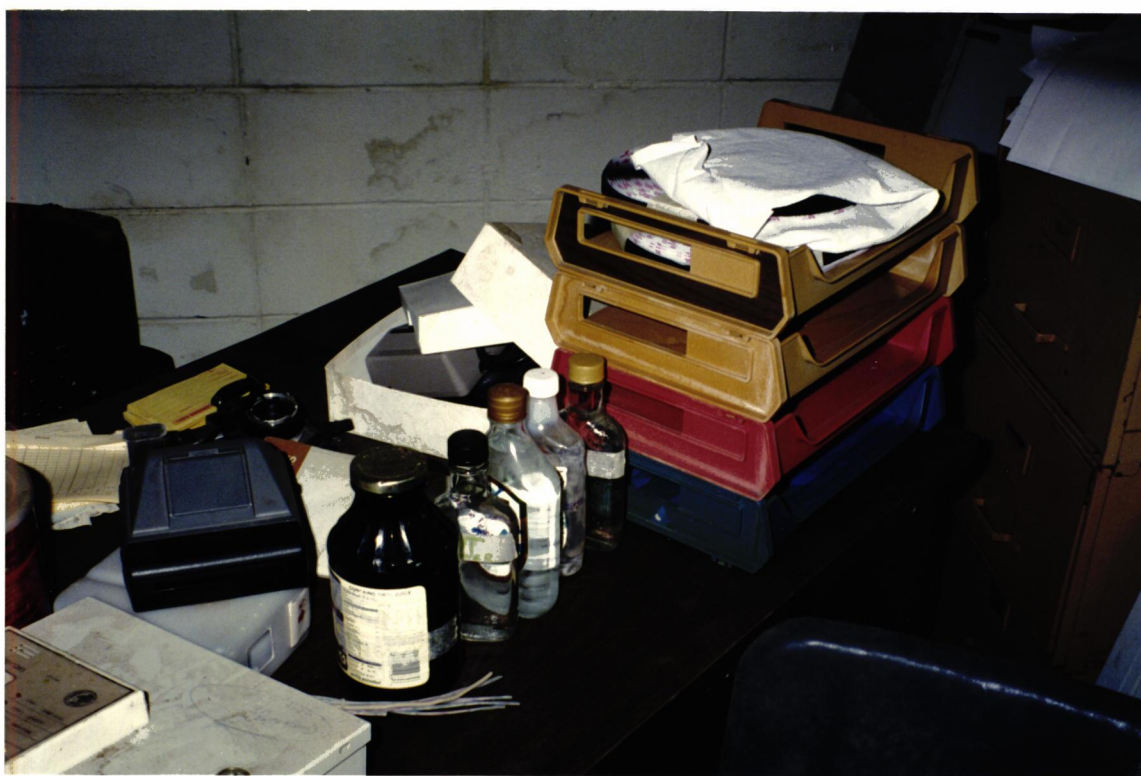
Facility: Thomas Hayward Agriculture & Nutrition
Location: Kansas City, KS **Photographer:** Jeffery Robichaud **Witness:** James Aycock **Date:** 6/27/95
Direction: South **Camera Type:** Fuji 35mm **Film Type:** 200 ASA **Time:** 0847
Subject: Picture of the desk in the southwest corner of the former lab room. Note the five bottles which are labeled as laquer thinner and paint thinner. The third bottle has a skull and crossbones drawn on it.

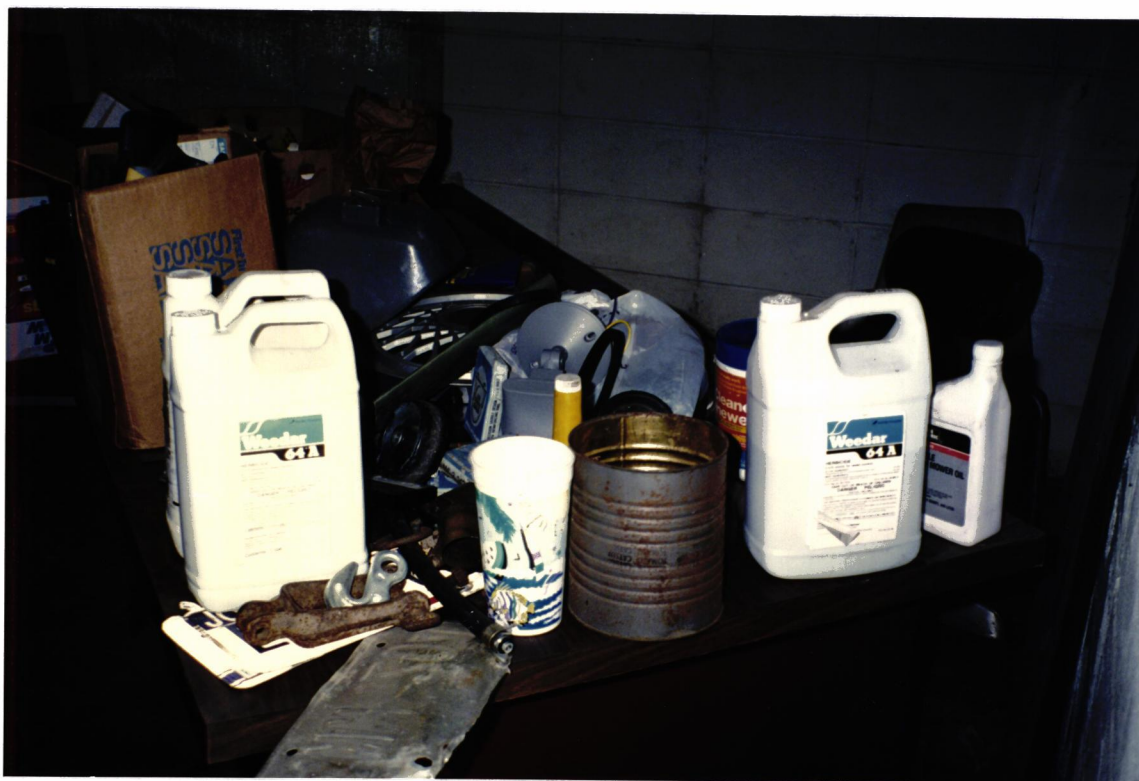
Facility: Thomas Hayward Agriculture & Nutrition
Location: Kansas City, KS **Photographer:** Jeffery Robichaud **Witness:** None **Date:** 6/27/95
Direction: West **Camera Type:** Fuji 35mm **Film Type:** 200 ASA **Time:** 0848
Subject: Looking at the desk just inside the west side of the north doorway to the former lab. Note the three containers of Weedar 64A which contains Herbicide 2, 4-D amine .

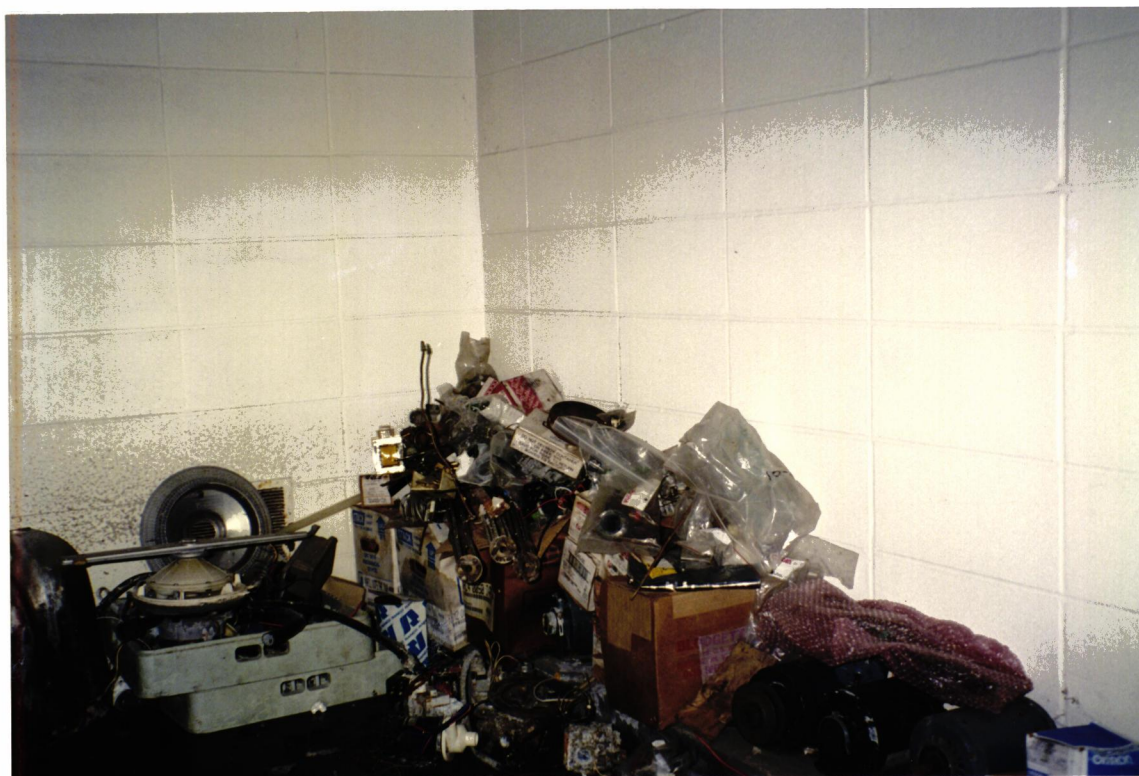
13

Facility: Thomas Hayward Agriculture & Nutrition
Location: Kansas City, KS **Photographer:** Jeffery Robichaud **Witness:** James Aycock **Date:** 6/27/95
Direction: South **Camera Type:** Fuji 35mm **Film Type:** 200 ASA **Time:** 0850
Subject: View of the former ladies bathroom depicting scrap/salvaged material in the southwest corner.

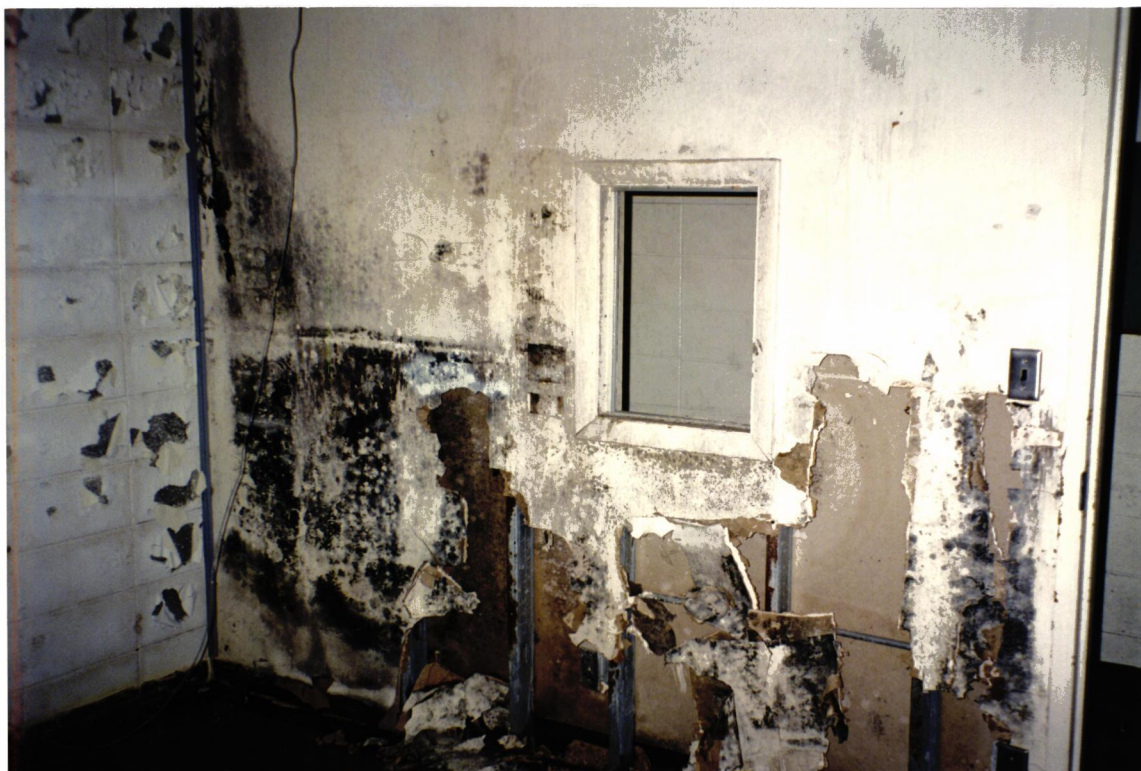
14

Subject: View of the southeast wall of the former tech room depicting the general condition of the room.

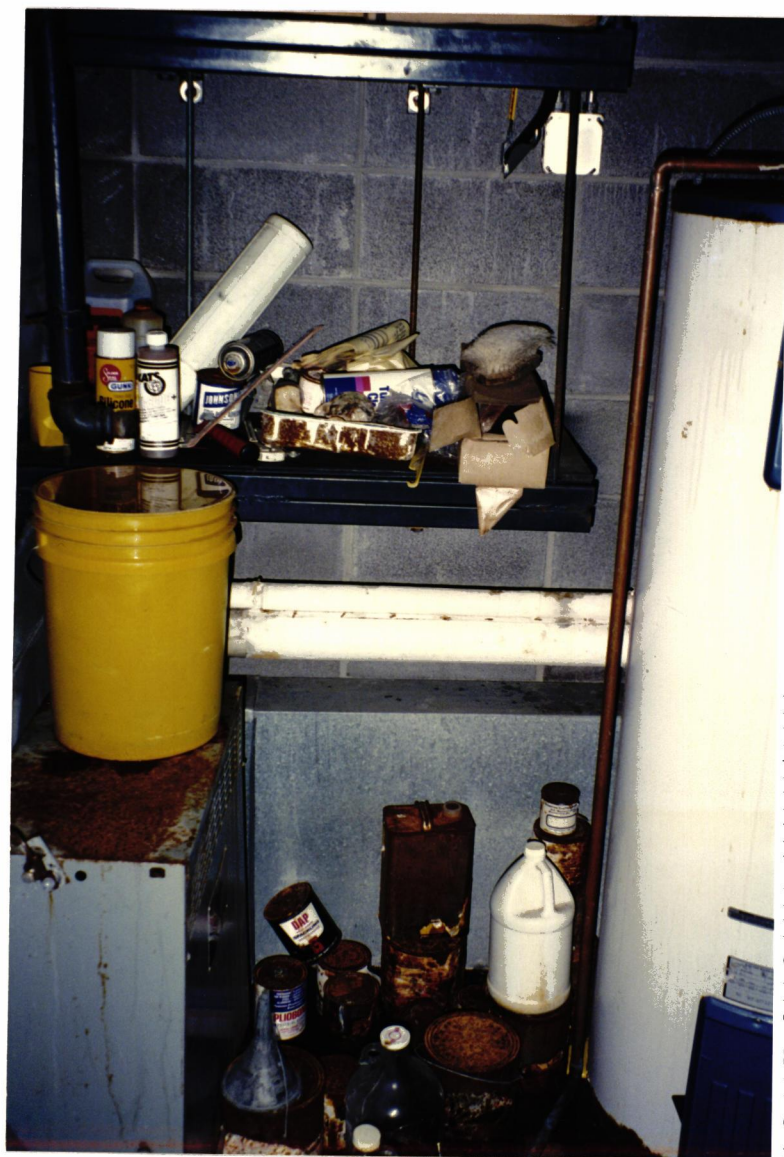
ROLL 1 PHOTO 15

Subject: View of the boiler room in the former laboratory/office building. Note miscellaneous containers of paints, solvents, and other materials.

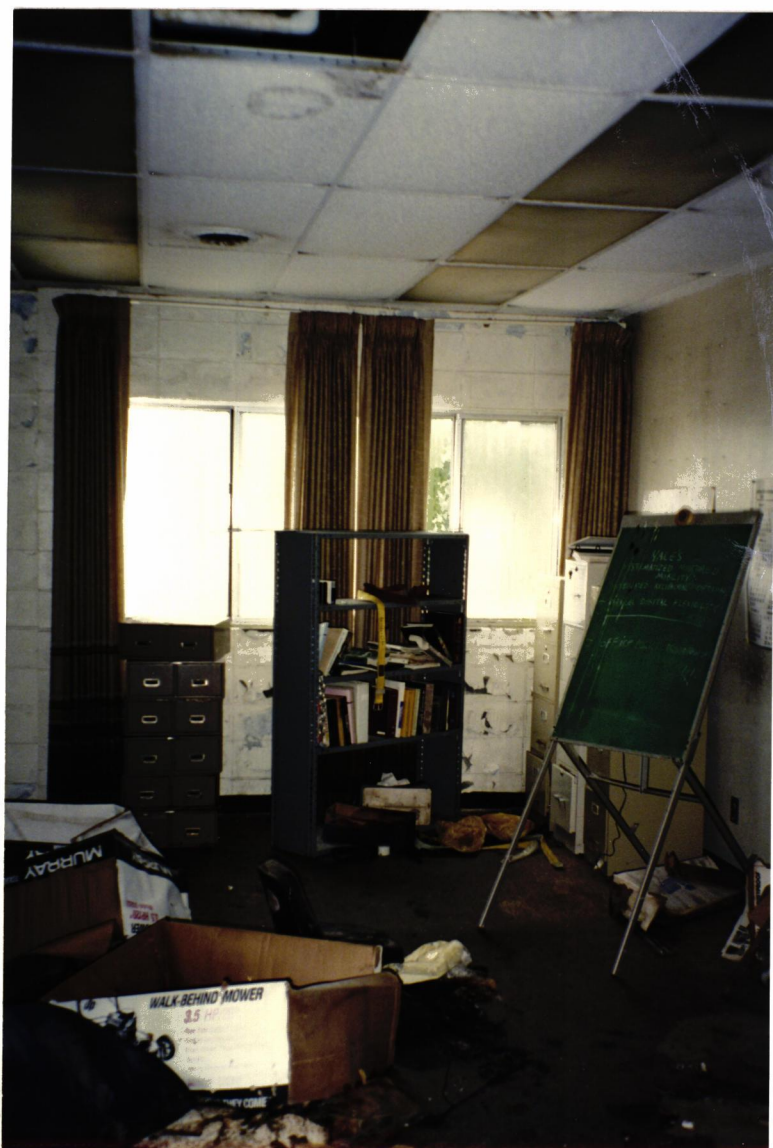
ROLL 1 PHOTO 16

Subject: View of the former breakroom area. Note the water damage to the floor and walls.

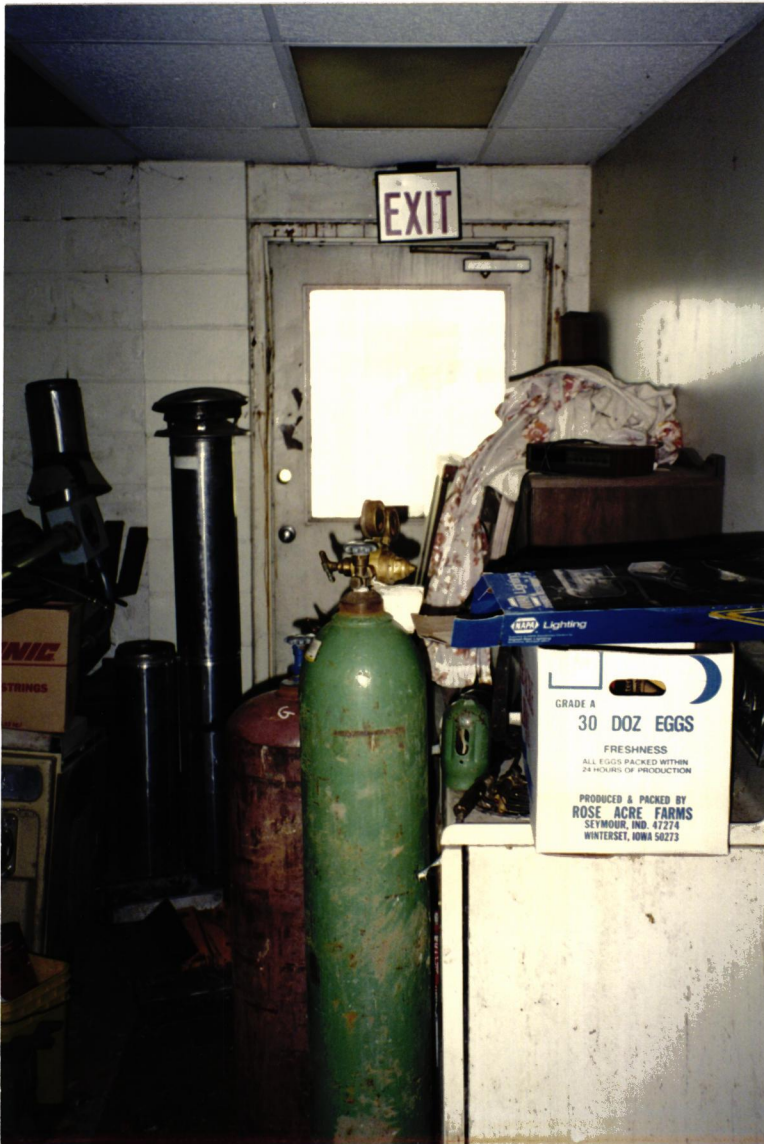
ROLL 1 PHOTO 18

Subject: View of the west-side office exit.
Note the two compressed gas tanks. One is labeled acetylene, the other oxygen.

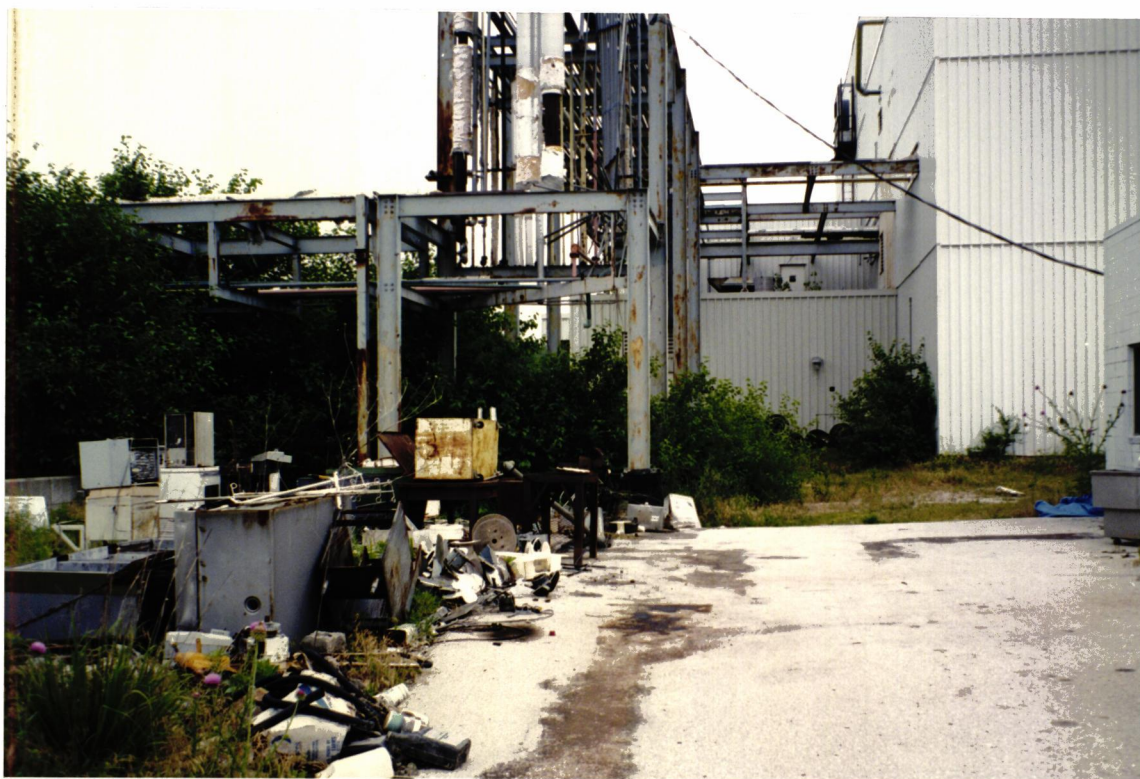
19

Facility: Thomas Hayward Agriculture & Nutrition
Location: Kansas City, KS **Photographer:** Jeffery Robichaud **Witness:** James Aycock **Date:** 6/27/95
Direction: East **Camera Type:** Fuji 35mm **Film Type:** 200 ASA **Time:** 0905
Subject: View of the chemical/product pipe rack leading into the DAITOM plant. Photo was taken from the north side of the laboratory/office building. Notice the old air conditioning units in the left side of the photo.

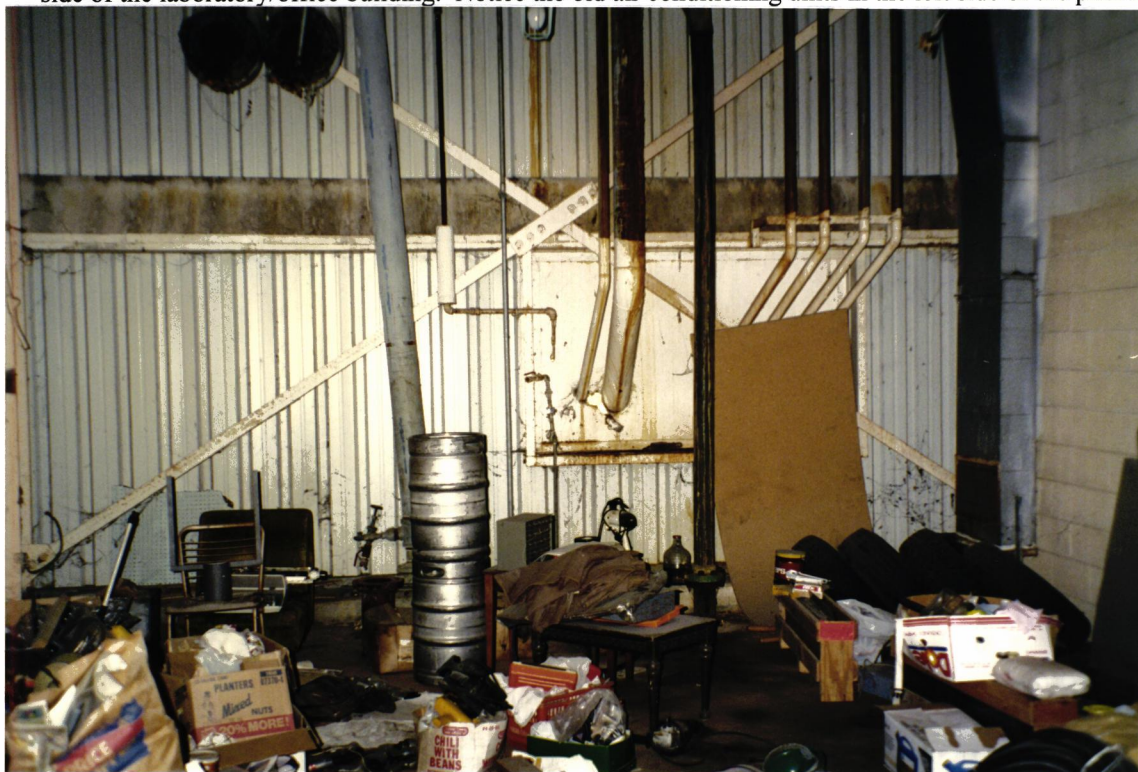
20

Facility: Thomas Hayward Agriculture & Nutrition
Location: Kansas City, KS **Photographer:** Jeffery Robichaud **Witness:** James Aycock **Date:** 6/27/95
Direction: North **Camera Type:** Fuji 35mm **Film Type:** 200 ASA **Time:** 0910
Subject: View of the former DAITOM plant production area. Note the miscellaneous scrap/salvage material.

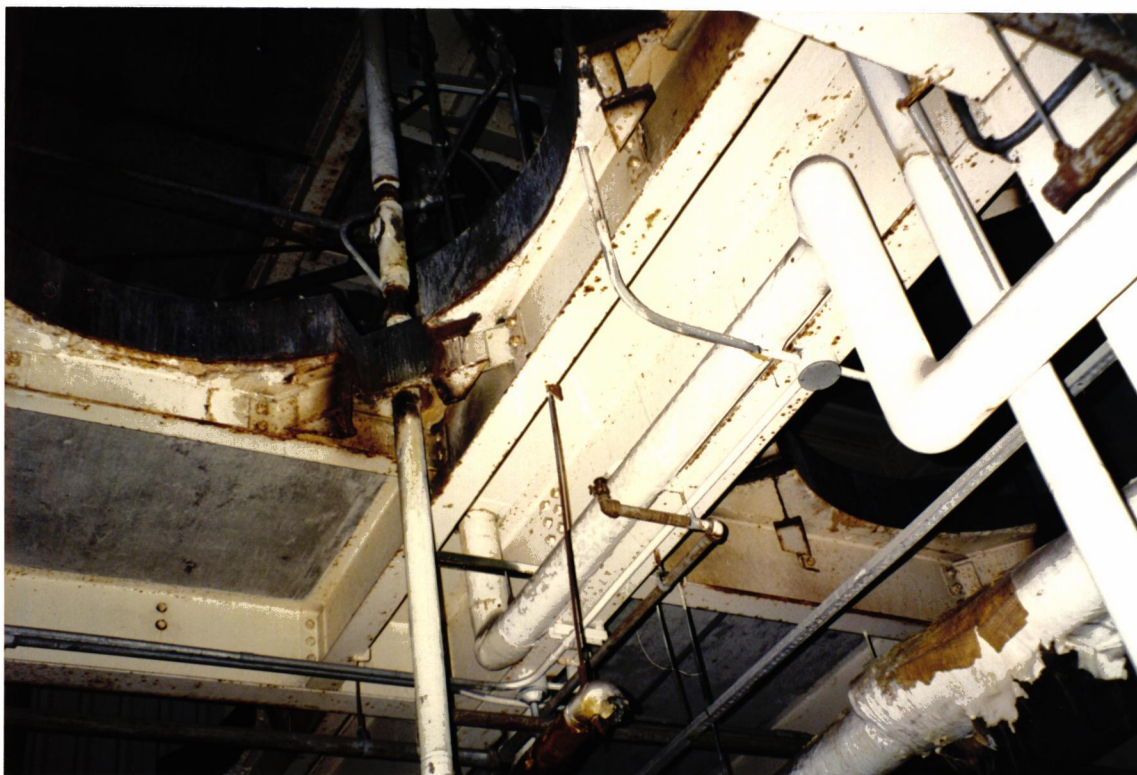
21

Facility: Thomas Hayward Agriculture & Nutrition
Location: Kansas City, KS **Photographer:** Jeffery Robichaud **Witness:** James Aycock **Date:** 6/27/95
Direction: Up **Camera Type:** Fuji 35mm **Film Type:** 200 ASA **Time:** 0910
Subject: View of openings in the ceiling (1st floor) that formerly housed methanol tanks and associated piping.

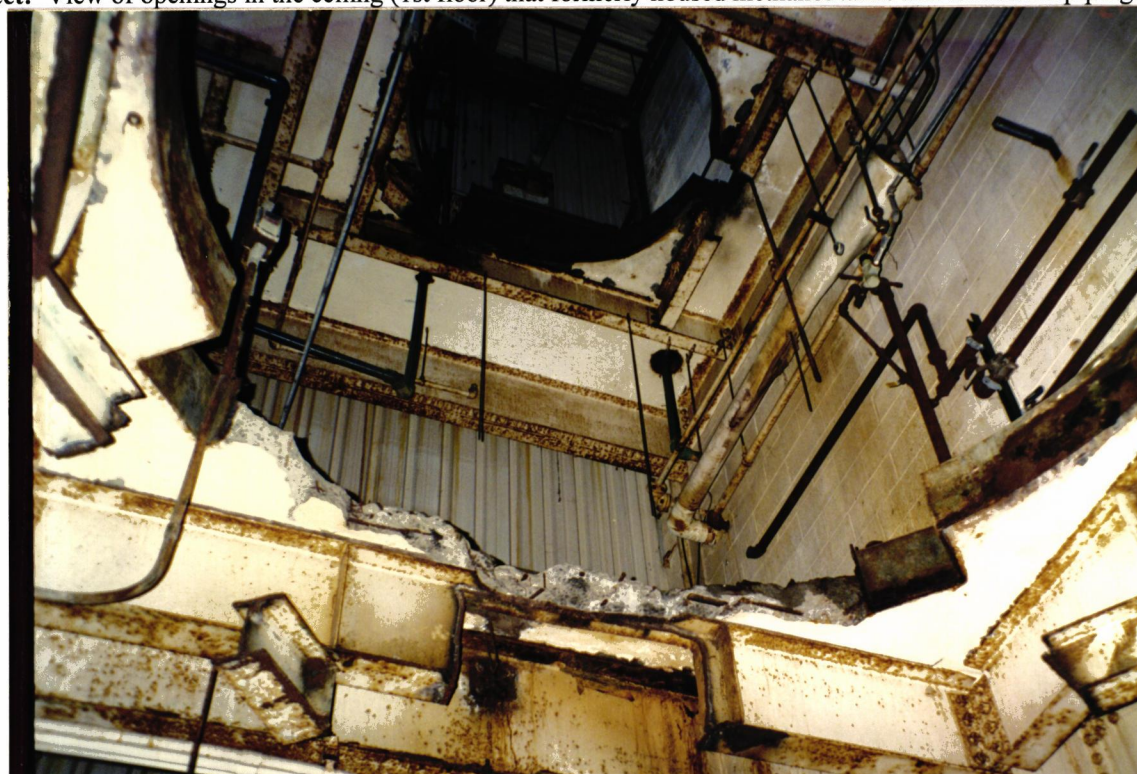
22

Facility: Thomas Hayward Agriculture & Nutrition
Location: Kansas City, KS **Photographer:** Jeffery Robichaud **Witness:** James Aycock **Date:** 6/27/95
Direction: Up **Camera Type:** Fuji 35mm **Film Type:** 200 ASA **Time:** 0914
Subject: View of opening in the ceiling (1st floor) that housed methanol tanks and associated piping.

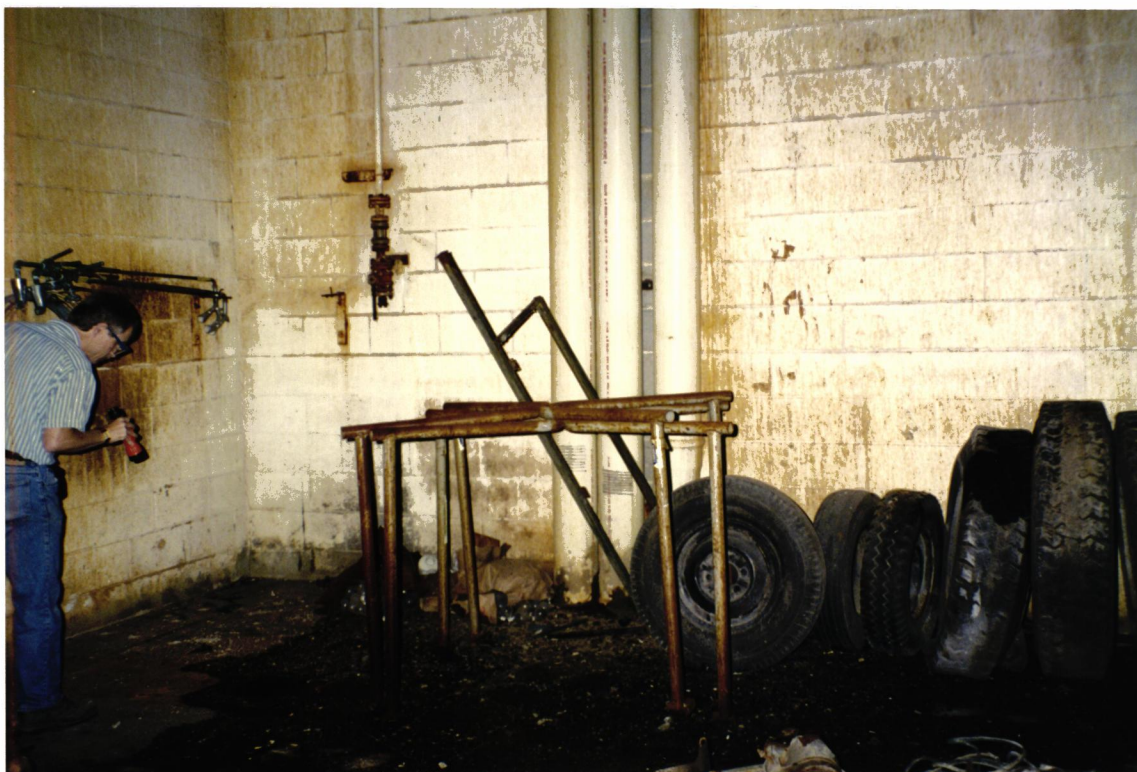
23

Subject: View of the former reactor room. Note scrap tires, light bulbs, and miscellaneous scrap/salvage material. Also note the drain to the left.

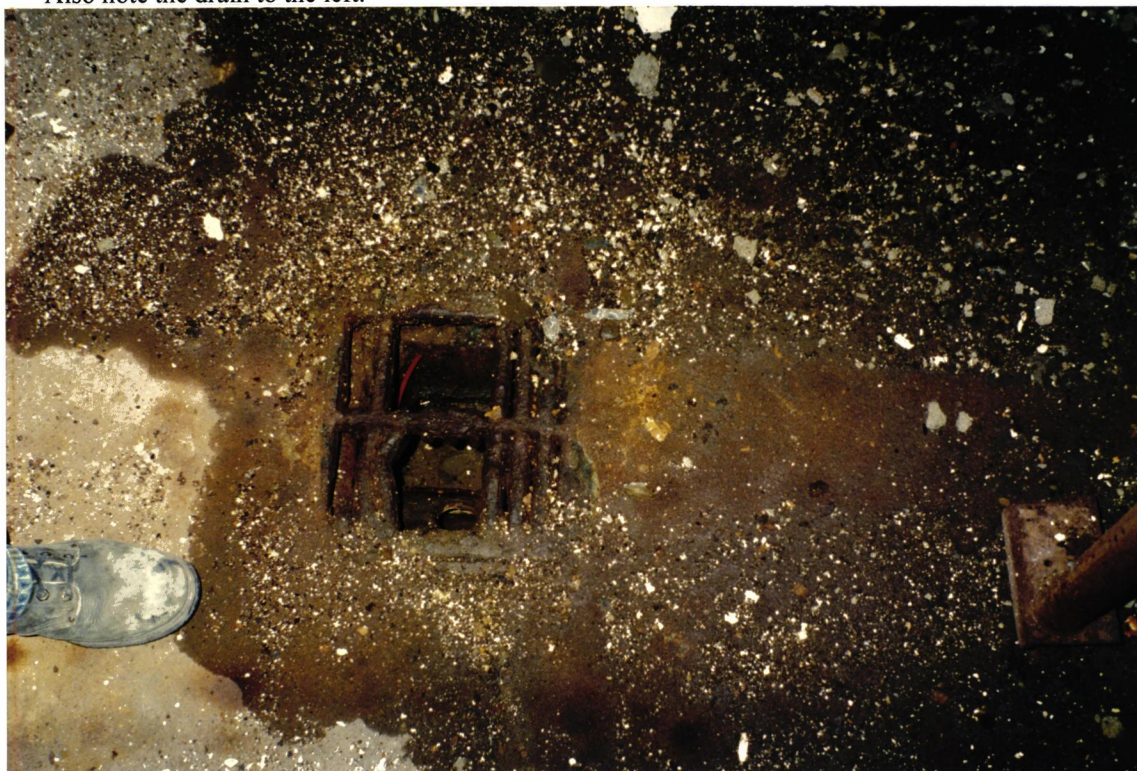
24

Subject: View of the drain in the northeast corner of the reactor room.

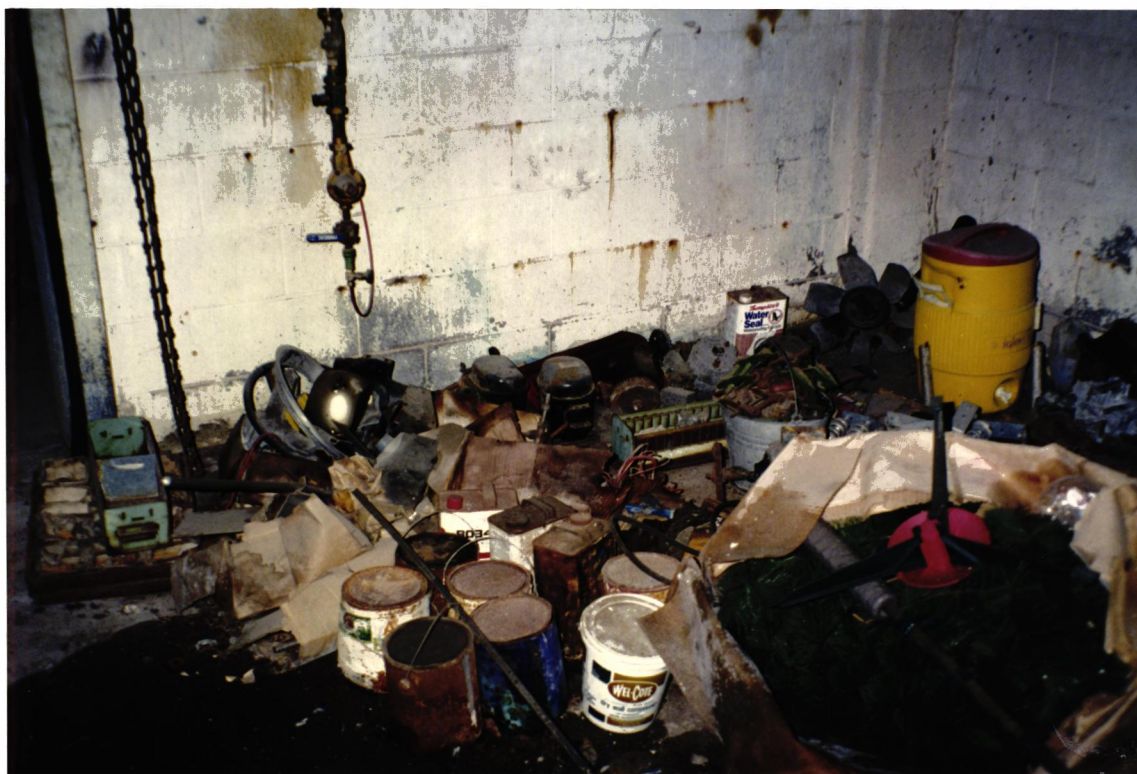
25

Facility: Thomas Hayward Agriculture & Nutrition
Location: Kansas City, KS **Photographer:** Jeffery Robichaud **Witness:** James Aycock **Date:** 6/27/95
Direction: Northwest **Camera Type:** Fuji 35mm **Film Type:** 200 ASA **Time:** 0922
Subject: View of miscellaneous scrap/salvage material in northwest corner of reactor room. Note numerous paint and solvent cans.

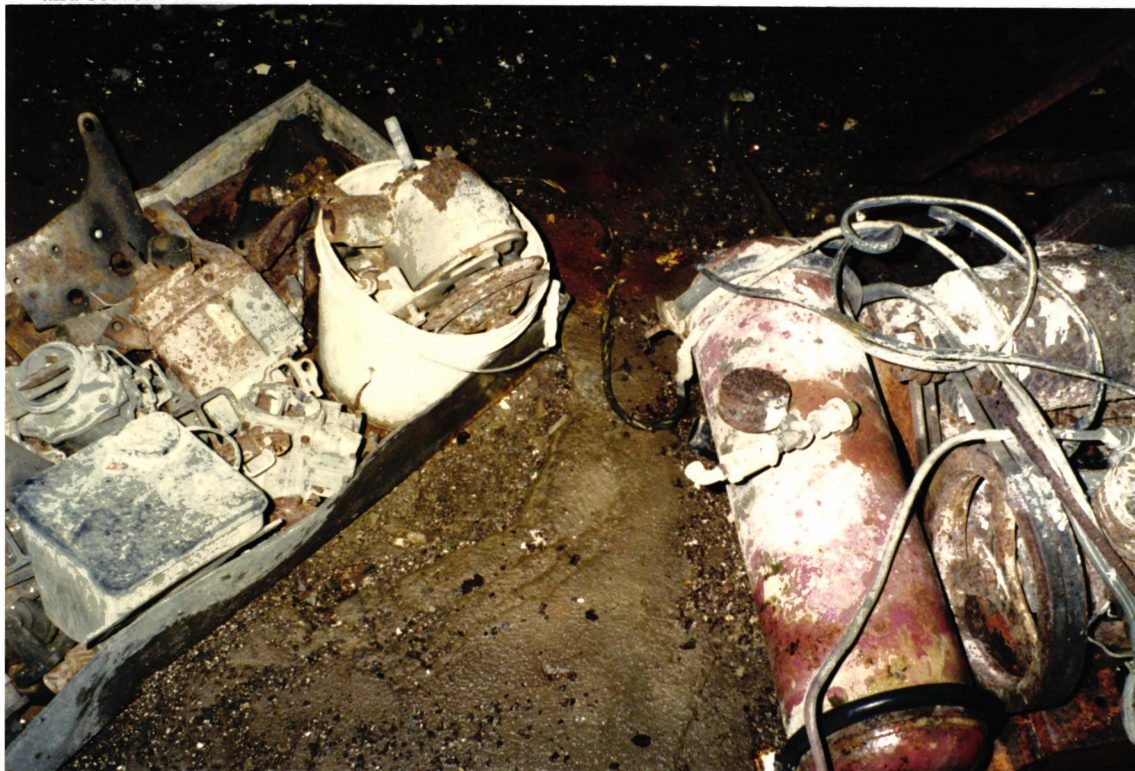
26

Facility: Thomas Hayward Agriculture & Nutrition
Location: Kansas City, KS **Photographer:** Jeffery Robichaud **Witness:** James Aycock **Date:** 6/27/95
Direction: N/A **Camera Type:** Fuji 35mm **Film Type:** 200 ASA **Time:** 0925
Subject: View of possible support for former tanks (between fire extinguisher and white 5-gallon bucket).

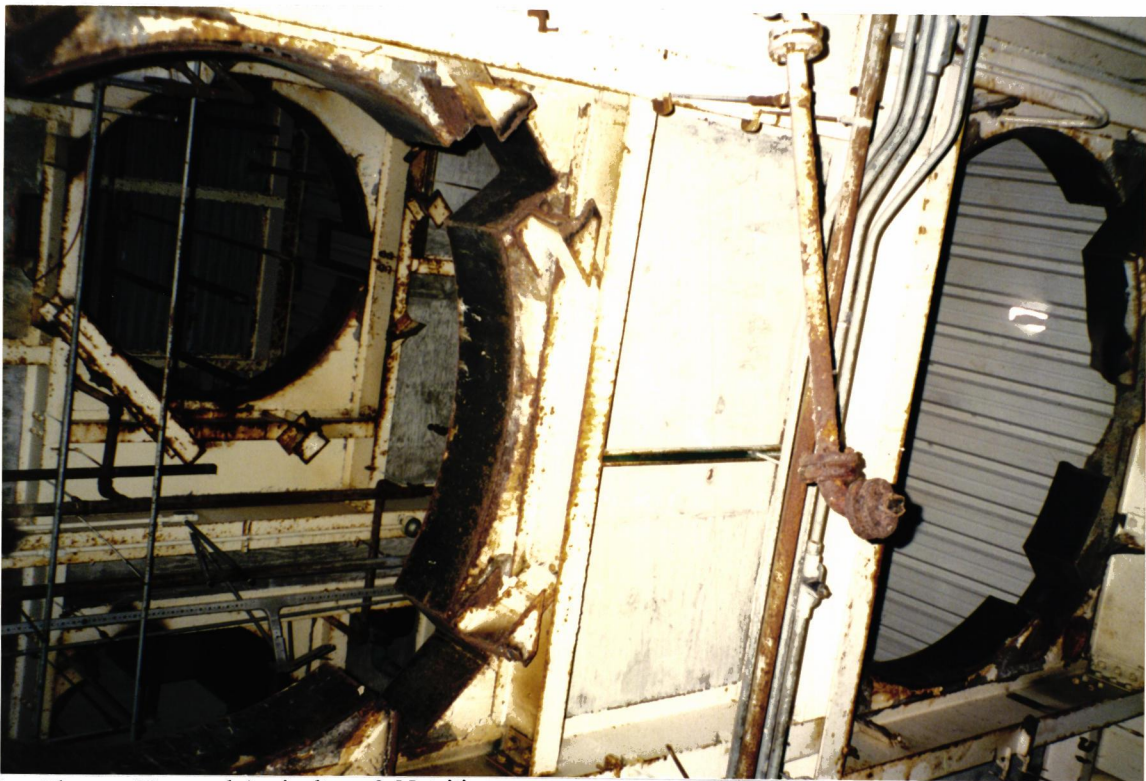
Subject: View of openings in the ceiling that housed tanks (1st floor).
